## LSWR G6 Class 0-2-0- No: 217

Manufactured by Connoisseur Models 33 Grampian Road, STOURBRIDGE, DY8 4UE Tel: 01384 371 418 <u>http://www.jimmcgeown.com/</u>

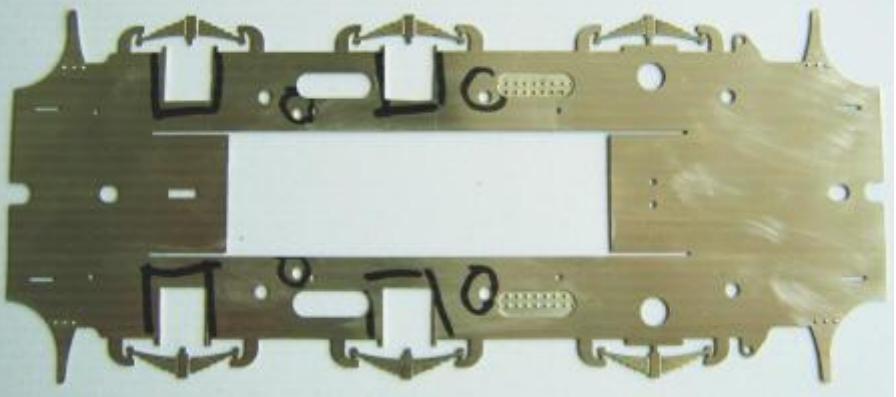
This required some modifications to the frames, the addition of another pair of holes for plunger pick-ups since only the front and rear-mounting holes come ready etched, plus a pair of holes for the compensation beam pivot and cutting out rectangular holes for the horn guides. This picture illustrates what is required and where extra holes were drilled.

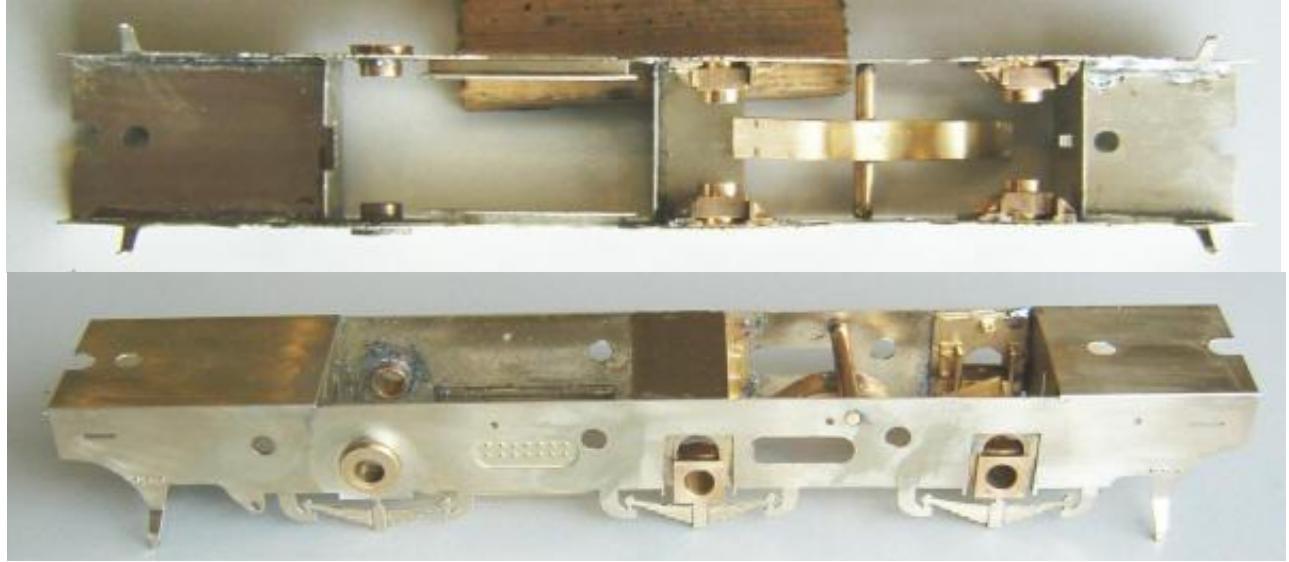
Because the motor has been moved, so too must the frame spacers and this allowed me to put one in the centre of the frames, which gave it a little more rigidity. Fitting the horn guides and compensation presented no problems and the following three pictures illustrate what was required to produce a robust set of frames.

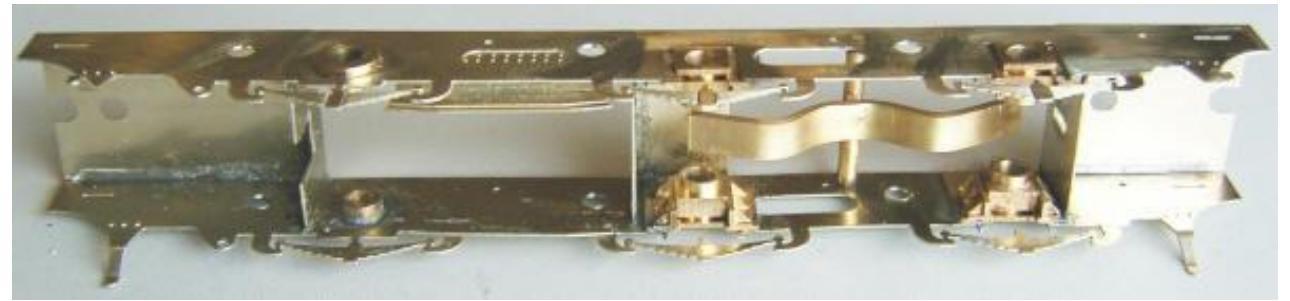
The wheels, motor and rods were then fitted and tested out on the rolling road. It worked first time and so I left it running for a couple of hours in each direction to run in the bearings.

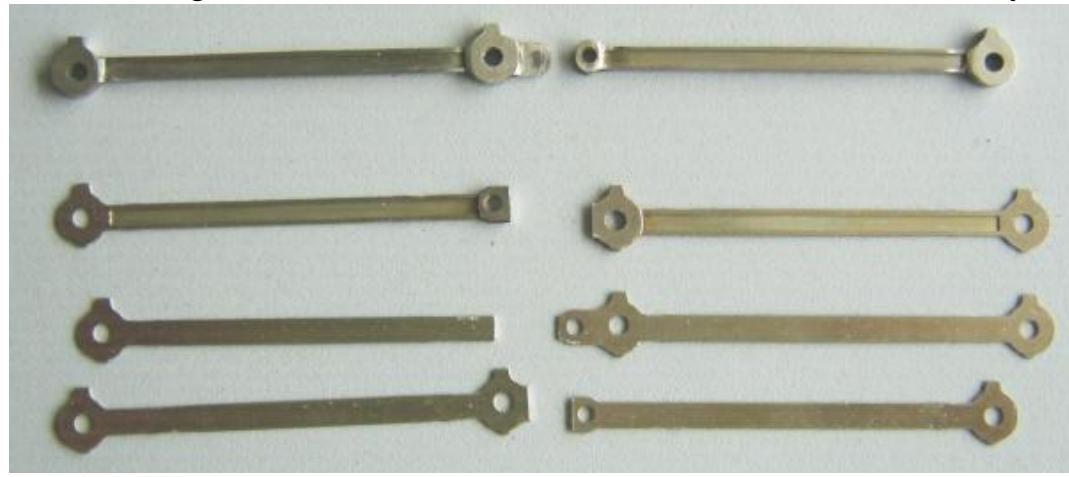
The rods as supplied are designed to be solid. Not a good idea with compensation so I modified them to be jointed as per the prototype by cutting the first and third laminate on one side of the joint, and the second laminate on the other side. They were then soldered up while held in the vice with pegs in the holes. I used lots of flux, 179 degree, 2% silver solder wire and an iron, a tool I use very rarely but for

this job essential. This picture illustrates the method; all they need now are a couple of 10BA steel nuts and bolts to make the pivot. The brake gear is well thought out, simple to fit and the brake blocks can be set very close to the wheels. I used nickel silver 1.3mm rod for the supports as that fitted the etched holes well and made a better joint. Sanding gear at the rear uses cast boxes soldered to the frames, the front pipes were fitted into suitable holes drilled in the frames. At each end of the frames, I built boxes using plasticard, fitted some tube to maintain a passage for the holding bolts and poured in liquid lead and dilute PVA. It gives a good deal of ballast low down where it is needed. However, it was all removed later after the disaster with the Prairie Tank.

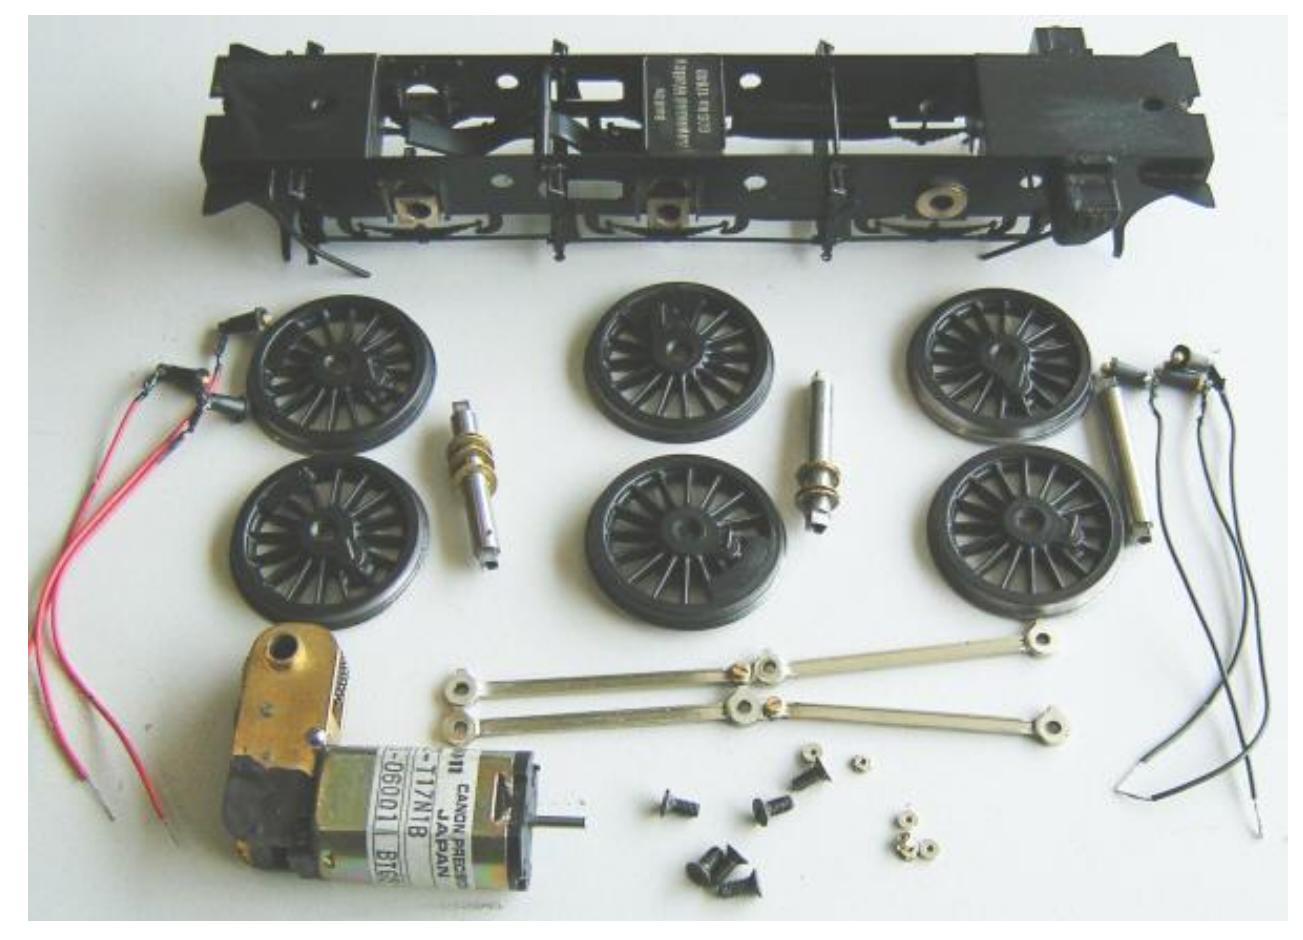
All the parts for the chassis complete and ready for re-assembly. All that remains is to change the pivot bolts in the rods for some steel 10BA bolts. Once it was all put back together more testing took place on the rolling road and, later, at the club on a test track. It was then that someone pointed out the wheels should have been painted green!

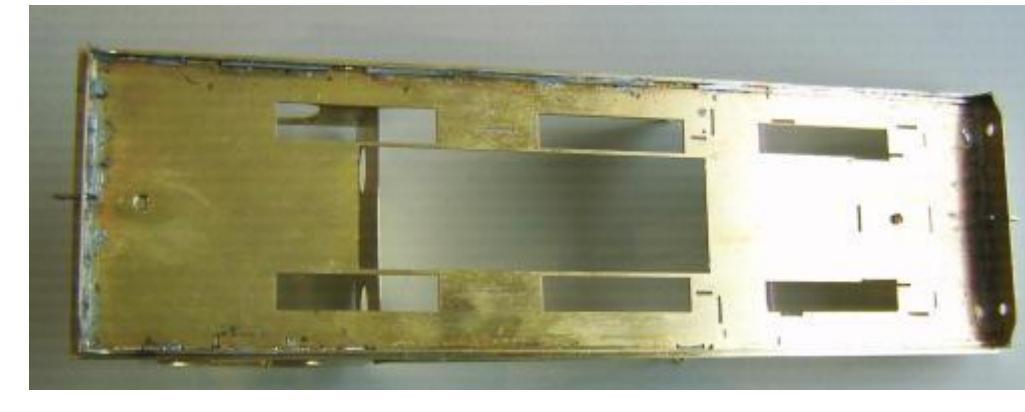
The footplate was strengthened behind the valances with some 1x1mm brass stock,

leaving spaces for the tabs that hold the cab to come through. Here are the parts partially assembled for the cab, tanks, boiler (which comes ready rolled) and

smoke box. The beading round the cab entrances and along the top of the tanks was fitted while in the flat.

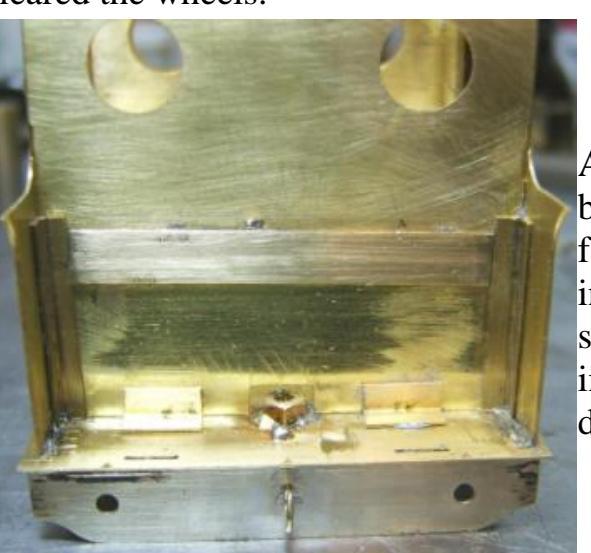
Another plate was added to extend the cab back down to the floor and sandboxes fabricated and fitted. This picture shews the inside of the cab looking to the rear. The sharp eyed among will notice I forgot to put in a coalhole so the fireman has a tough job to do.

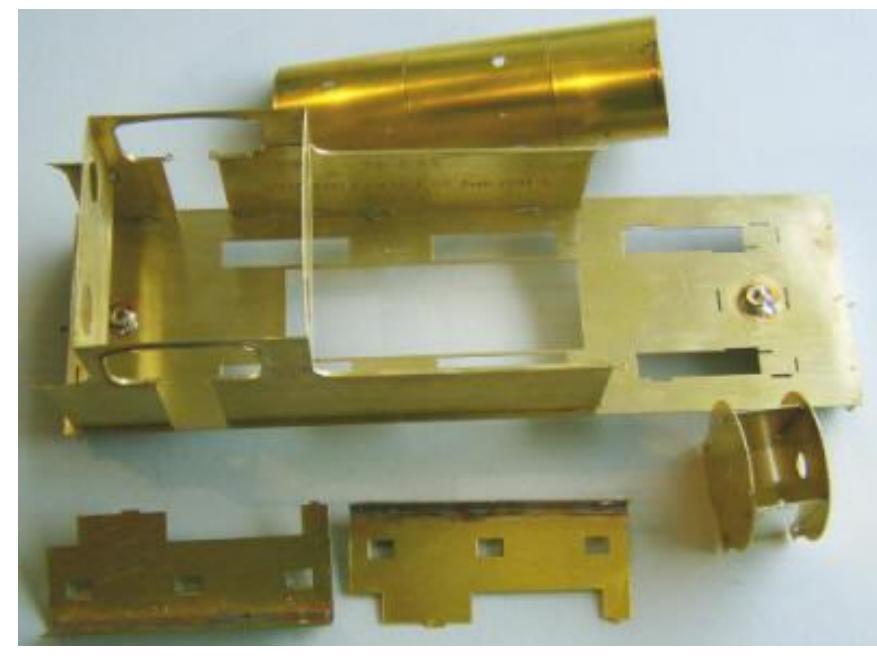
Here the smoke box has been completed, fitted and the back ring soldered on. The back ring started life as a length of 1mm square rod which was held in a groove in some timber so that the corner was uppermost and then filed to a round section. It was then annealed and bent round some brass rod of lesser diameter than that of the boiler. After sliding it onto the boiler, the smoke box

was soldered in place. However, this required some brass rod of suitable diameter to be passed through the smoke box to line up with the half hole in the boiler front. This ensured that the boiler

and smoke box are soldered parallel. The ring can then be soldered in place. Not easy but doable.

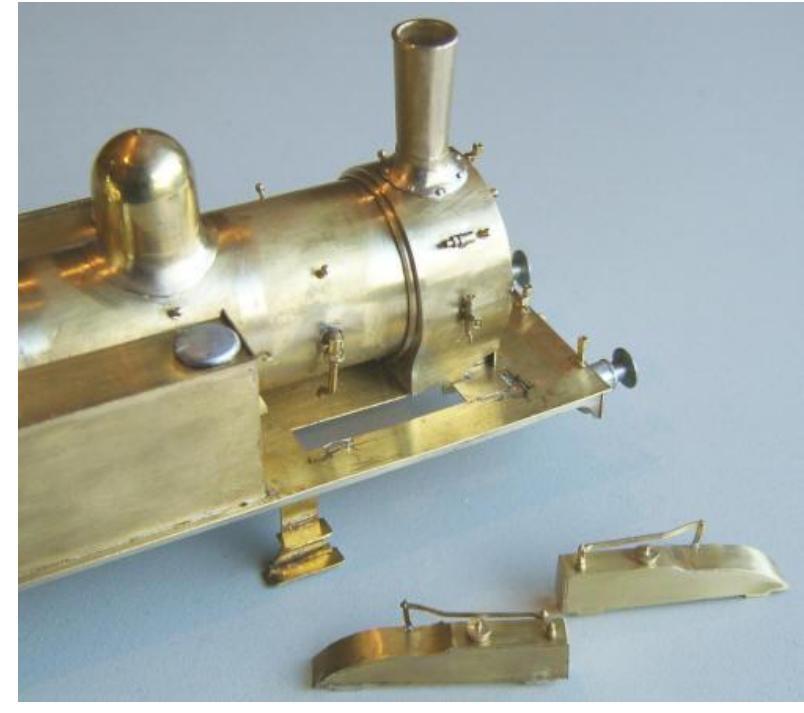
The steps needed strengthening with some 0.7mm wire behind them. The kit has a choice of cast white metal and etched front wheel splashers. I chose (naturally) the etched version since the picture of the engine I am building has square fronts and no beading while the cast version has rounded fronts and beading. The sand box tops

and operating links are castings from Laurie Griffin.

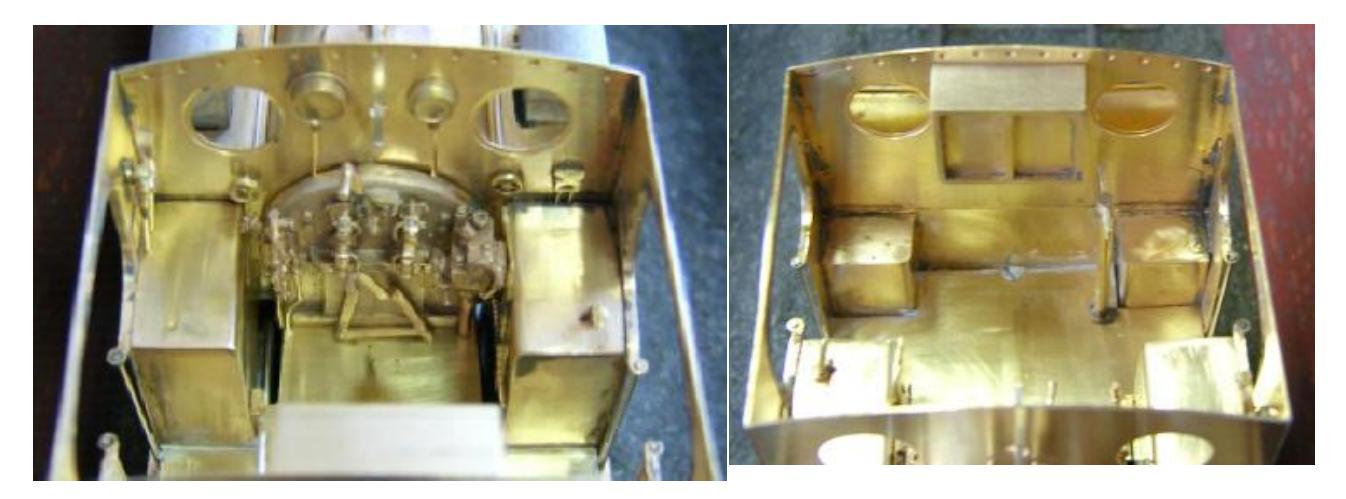
Finishing off took longer than expected because I had forgotten to check for things like a reversing lever. Fortunately, I had one very close to the drawing's shape in the spares box. There is a great deal to build for the cab as can be seen in these two pictures. The etched dimples in the cab front and back are where the ventilation holes would go but this engine seems not to have had them or the curious curved

The back head is held in with blue tack so the painter can get to it more easily. The floor had to be fabricated after the cab was built, it ought to have been thought of before; the job would have been easier and more accurate. The reversing lever is not quite right but what can be seen through the cab side looks OK. The cabinet on the back wall was fabricated from solid brass and then stuck on with Loctite 480. I had intended to leave the handrails off until after painting. However, the problems is fitting them - in several parts round the boiler - would have put the paint job at risk so they will have carefully to be cleaned when it comes back from Ian's paint shop.

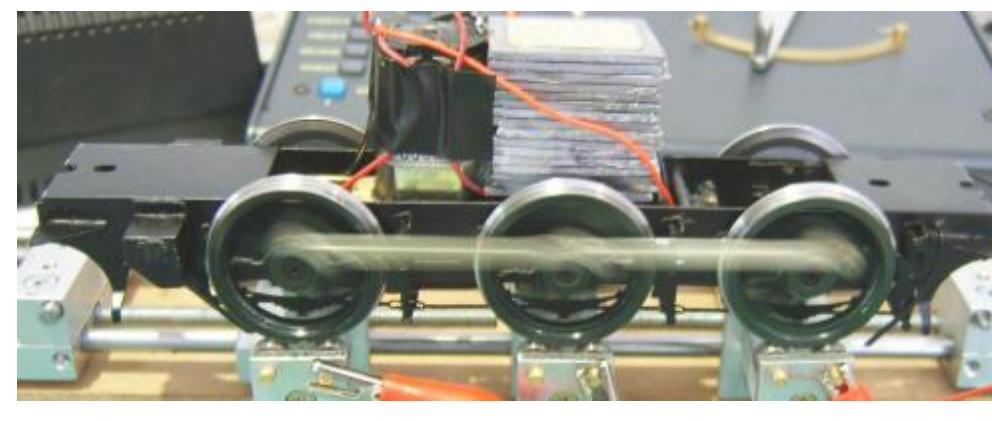
One of the problems of building to deadlines - whether self imposed or otherwise - is the ever-present danger of something not going right. Well this little engine was no exception to that rule. Though it ran nicely on straightish track, on some of the curves it occasionally shorted out. This turned out to be due to wheels touching the brake rodding. (Moral? test it out on some curves before completion, not just a rolling road). This necessitated taking the chassis apart, stripping the paint from the frames, repositioning the rods behind the springs, repainting and reassembling. Ah well, we learn one way or another. Whilst the chassis was in bits I took the opportunity to change the fixing for the motor by analditing half a pound of lead behind it, right over the centre drivers. Here

it is being checked out again, now weighing one and a quarter pounds. The body weighs another pound so it should be able to pull more than the skin of a rice pudding. The

Well this turned out not to be a good idea after all. It made running poor and erratic so was all removed. A piece of stiff foam was fixed where the lead had been to hold the motor upright and the whole thing put back together again. It ran well at the Guildford Group's open day hauling about 30 wagons each weighing about 130 grams, getting on for 4 kilograms. Unfortunately, something was not well with the motor because after a dozen or so laps it burned out! This is still being investigated so more to come later. In the meantime, I have fitted an MSC unit. It runs nicely with that but now needs another long haul test.
